ASOS MODIFICATION NOTE 7 (for Electronics Technicians)

SUBJECT : Automated Surface Observing System (ASOS) Software Version 2.0

PURPOSE : To add maintenance capability and operational enhancements for the ASOS.

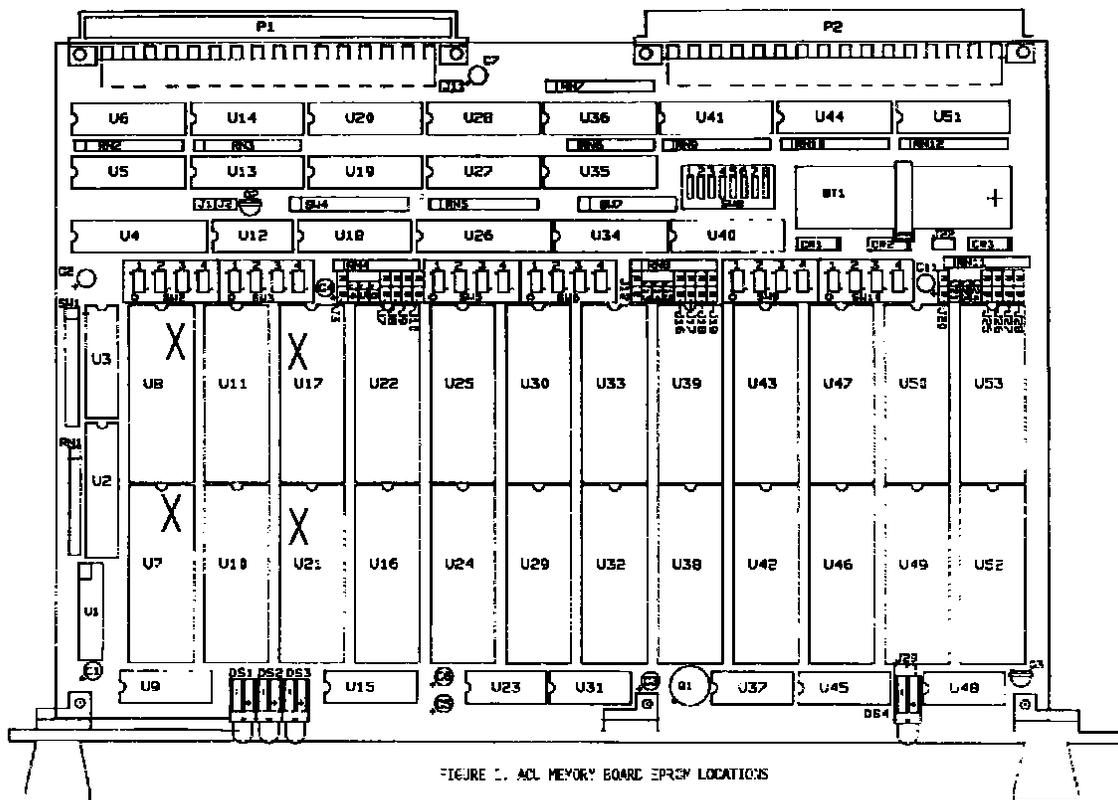
FIGURE 1. ACL MEMORY BOARD EPROM LOCATIONS

All ASOS application software is contained on four erasable programmable read only memory (EPROM) integrated circuits (IC) on ACU memory board 1A2A3. Figure 1 illustrates the ACU memory board and identifies the four EPROMs (U8, U17, U7, and U21). The EPROMs are 32-pin dual in-line package (DIP) CMOS devices, each providing 512K x 8 bits of storage. Upgrading ASOS software requires only replacing the four EPROMs on the ACU memory board with higher revision level ICs.

4. Using IC insertion tool, remove new EPROM integrated circuits from protective packaging and insert into ACU memory board sockets in accordance with the following chart. Ensure that EPROMs are installed with pin 1 (as identified by notch in top of IC) oriented toward board connector P1 as shown on Figure 1.

IC socket	IC part number
U8	62828-45002-1
U17	62828-45003-1
U7	62828-45004-1
U21	62828-45005-1
