AWIPS SYSTEM MODIFICATION NOTE 17 (for Electronics Systems Analyst)
Maintenance, Logistics, and Acquisition Division
W/OPS12: JCS

SUBJECT : Firmware upgrade to the Radiosonde Replacement System (RRS) modem in LDAD modem nest.

PURPOSE : To provide firmware upgrading instructions for RRS modems.

EQUIPMENT AFFECTED : Advanced Weather Interactive Processing System (AWIPS), RRS modem.

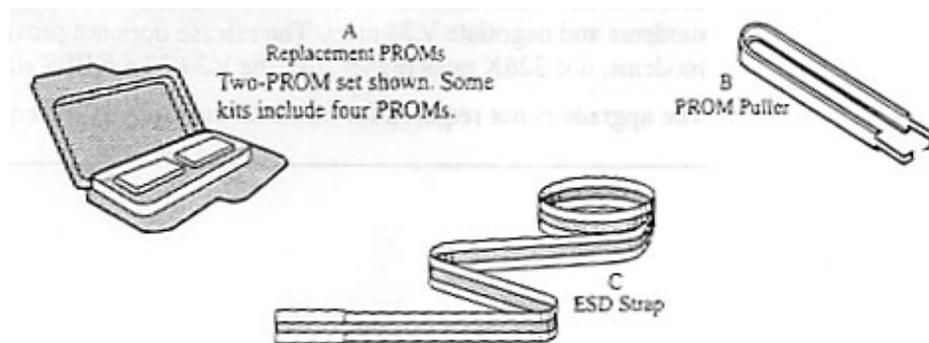
Figure 1

PARTS REQUIRED : Two field modification kits (FMK). Each FMK contains a two-PROM set, a PROM puller, a manufacturer's instruction manual, and an Electro-Static Discharge (ESD) strap. (See Figure 1)

NOTE: 1. Affected sites receive two FMKs containing: a two-PROM set, a PROM puller, and an ESD strap.

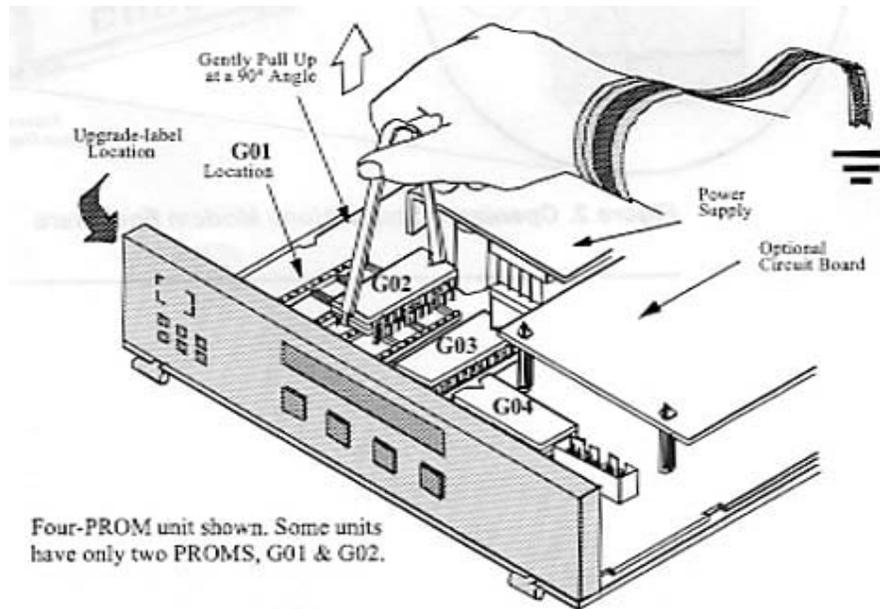
Figure 2

(Figure 2 shows PROM G02 being removed).

1. Remove PROMs.
 - a. Attach the ESD strap to your wrist and to a grounded item.
 - b. Remove the card from the AS2 modem nest, slot A16.
 - c. Hold the PROM puller at a 90-degree angle to PROM G01. Gently loosen the PROM pins by pulling up and rocking the PROM from end to end. Remove PROM G01

- d. Repeat step c for removing PROM G02.
