Subject: **Mod 73**

Problem: **CPU does not retain the Site Specific Information**

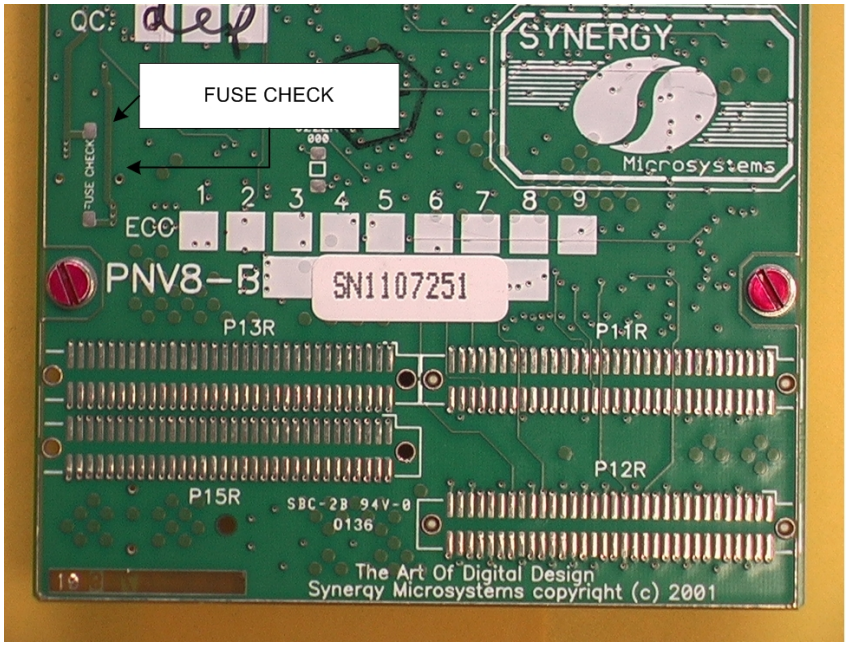
Solution: The new CPUs are shipped to the field with the battery backup disabled. The reason is to preserve the battery life while the boards are not installed in a system. This is accomplished by moving the fuse on the daughter board from the active position (FC31) to the spare position (FC32).

If the fuse is not moved to the active position, the site specific information will be lost when power is removed from the VME rack.

A fuse must be installed in the active position prior to installation. The fuse in the spare position can be moved to the active position or an additional spare fuse can be installed if one is supplied with the CPU packaging.

The fuse can be checked using an Ohm Meter by measuring between the “FUSE CHECK” test points on the back of the daughter board. This is easily accessible by laying the CPU track side down. The “Fuse Check” test points are located next to the daughter board part number stencil (PNV8-B) and a mounting screw closest to the CPU edge connector. The resistance should measure 1 ohm +/- 0.2.
